Figure S3. Supporting information for the article “*Recovery of a mining-damaged stream ecosystem*” by Mebane, C.A., R. J. Eakins, B.G. Fraser, and W.J. Adams. doi:10.12952/journal.elementa.000042.s003

This file includes photographs of habitat features at selected study sites, including substrates and organisms.

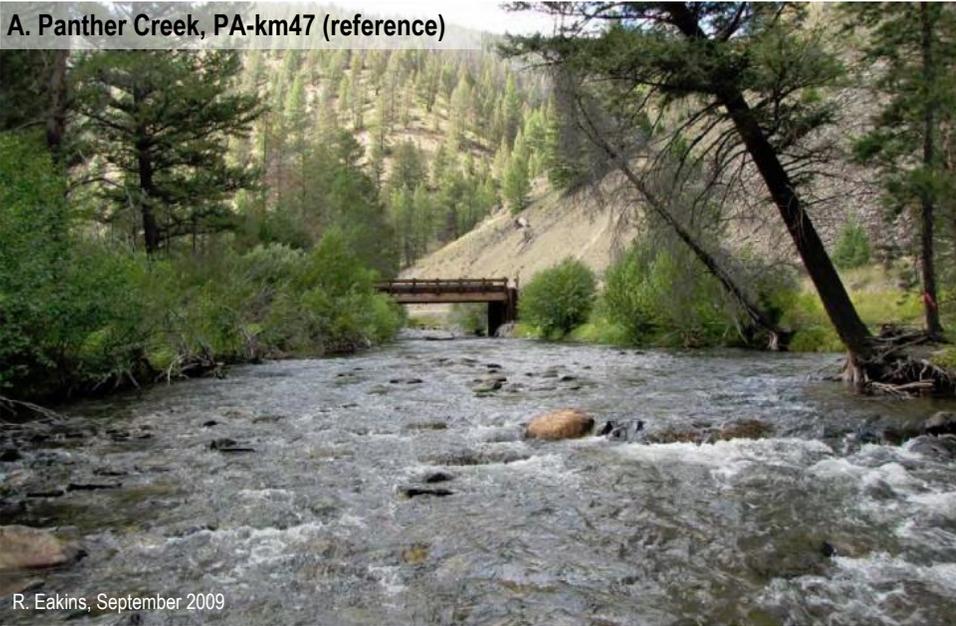
A. Panther Creek, PA-km47 (reference)

Figure S3-2. Long-term monitoring reference sites on Panther Creek upstream of Blackbird Creek. **(A).** Site PA-km47 is located about 7.5 km upstream of the Blackbird Creek confluence.

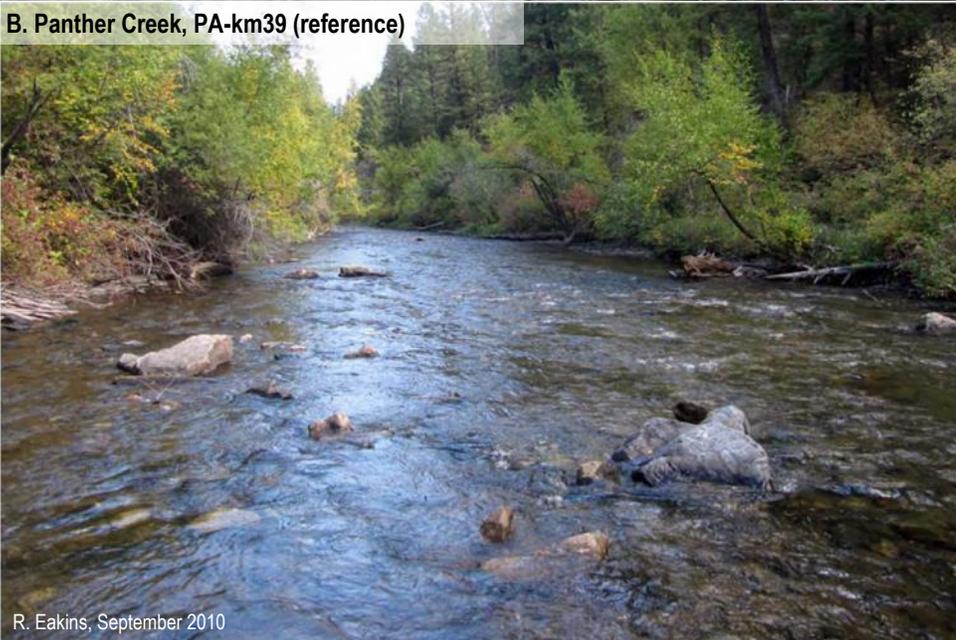
B. Panther Creek, PA-km39 (reference)

(B). PA-km39 is located about 0.3 km upstream of the Blackbird Creek confluence. At these two sites, Panther Creek is a 4th order stream, with mean wetted widths of about 12 and 14m respectively.

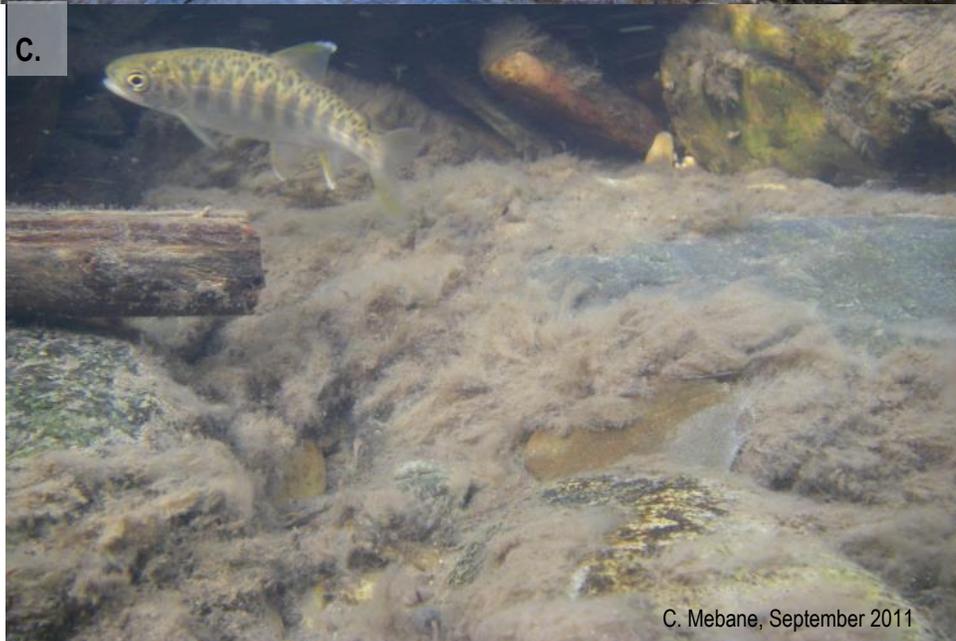
C.

(C). View of substrates at Panther Creek site PA-km39. Substrates in Panther Creek upstream of Blackbird Creek are typically covered with light periphyton (biofilm) growth and little accumulation of fine particles.

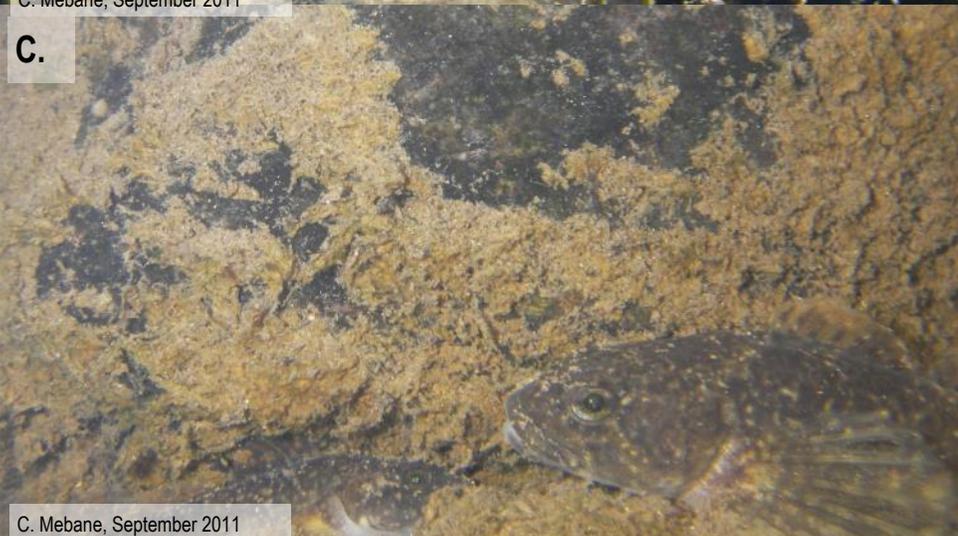
C.

(C). Shorthead Sculpin (*Cottus confusus*) against substrates in Panther Creek downstream of Blackbird Creek, PA-km37.

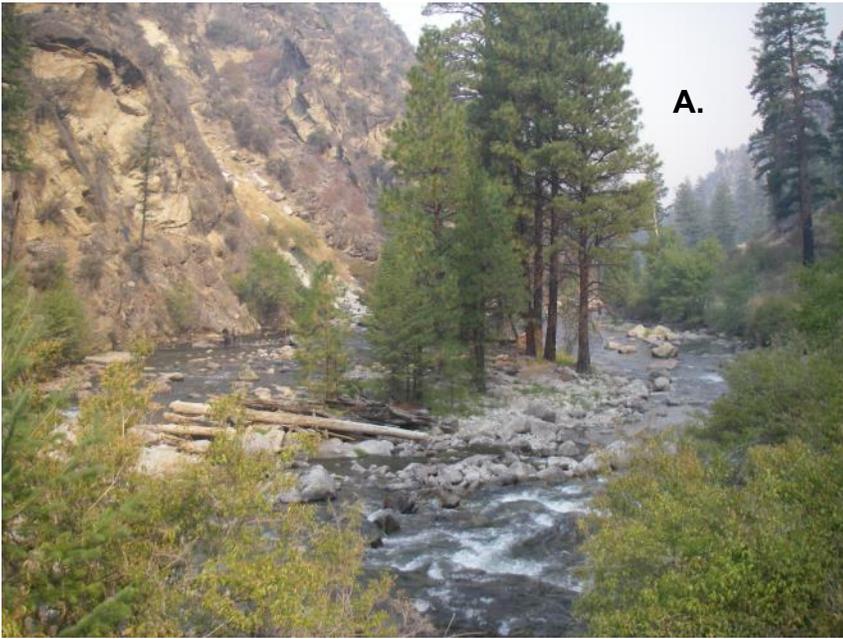
A.

(A). At this site, Panther Creek is a 5th order stream, with mean wetted channel widths of about 34 m. (B). Fish sampling at this location was also undertaken in a side channel in order to get adequate blocknet closure

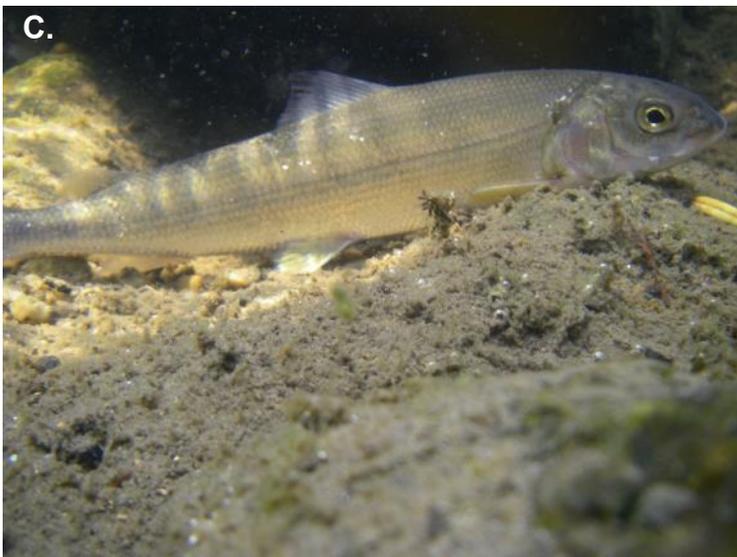
C.

(C). Fine-grained substrates in quiescent pocket water with a Mountain Whitefish, (*Prosopium williamsoni*), and

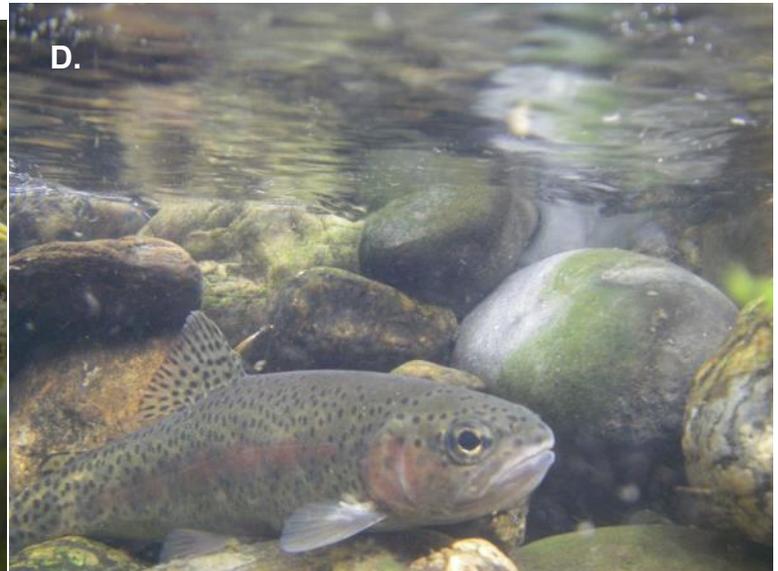
D.

(D). cobble substrates in faster water with a Rainbow Trout. Substrates are visually indistinguishable from those at reference sites.

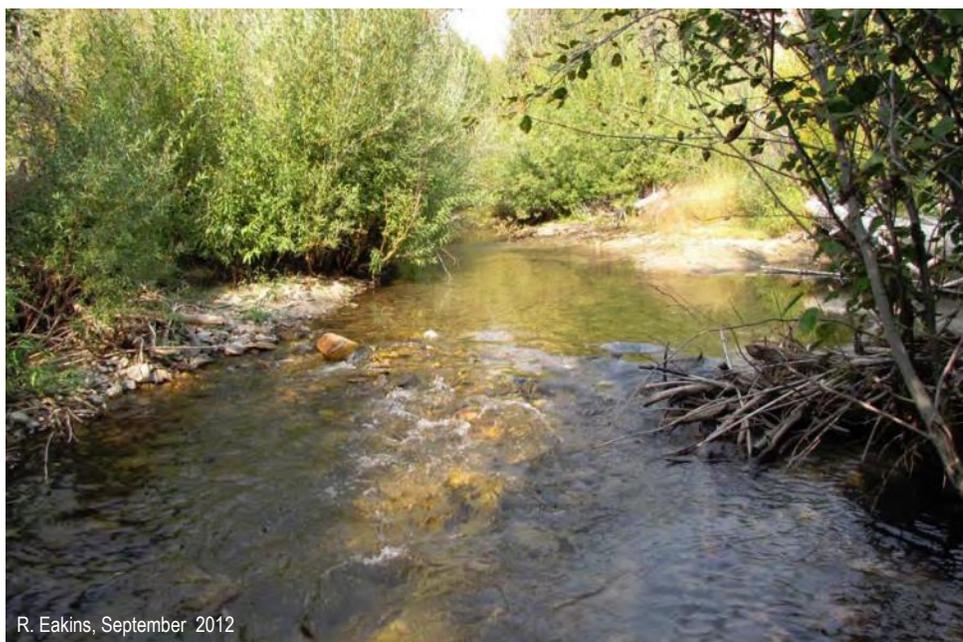
A. Big Deer Creek, BD-km5.6 (reference)

(A) Big Deer Creek upstream of South Fork Big Deer Creek (BD-km5.6). This reference site, located about 0.2 km upstream of the confluence with South Fork Big Deer Creek, generally serves as a reference site for mine-influenced sites Big Deer Creek.

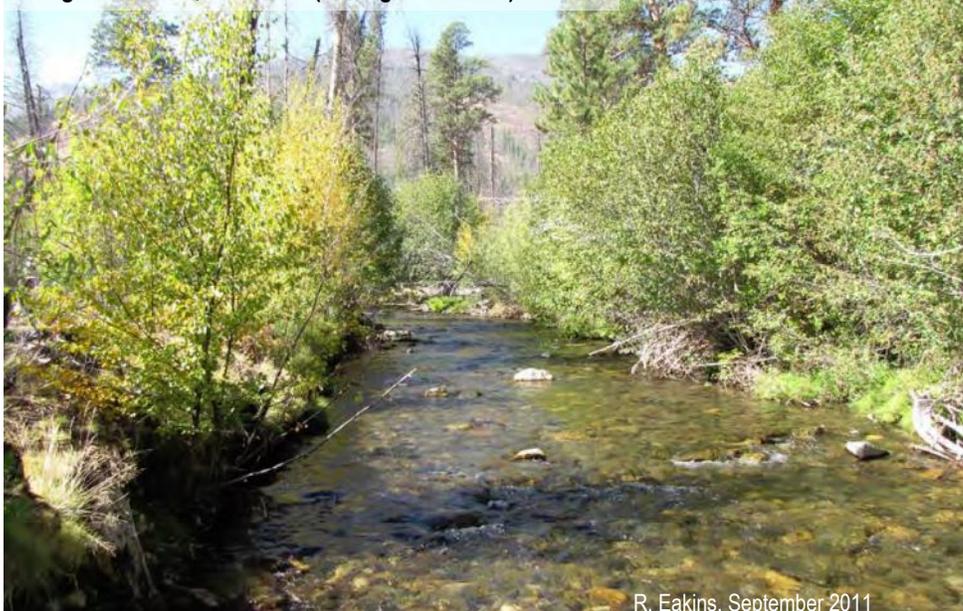
B. Big Deer Creek, BD-km5.3 (mining-influenced)

(B) Big Deer Creek downstream of South Fork Big Deer Creek (BD-km5.3). This mining-influenced site is located about 0.1 km downstream of the confluence with South Fork Big Deer Creek.

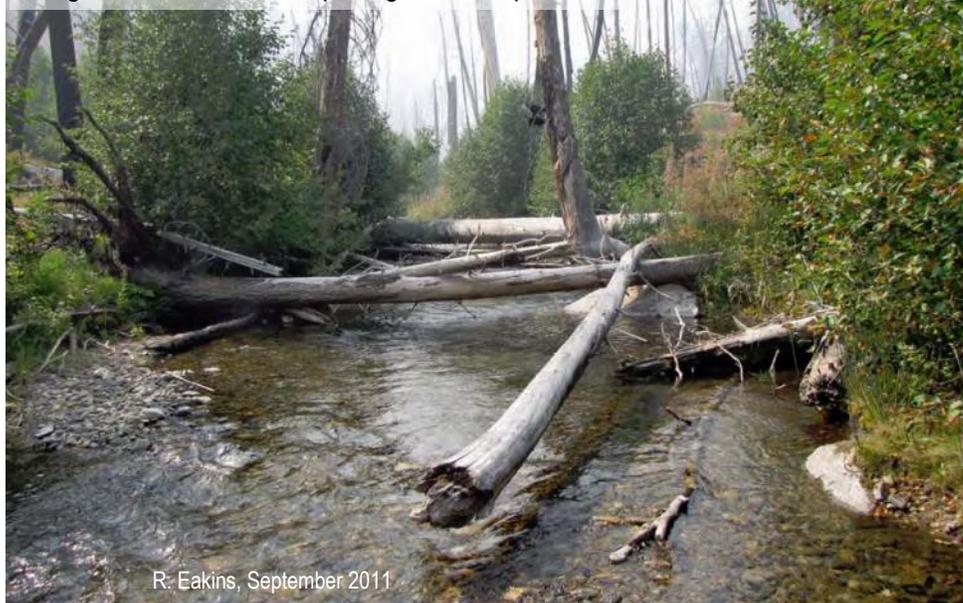
C. Big Deer Creek, BD-km2.4 (mining-influenced)

(C) Big Deer Creek downstream of South Fork Big Deer Creek (BD-km2.4.) This mining-influenced site is located about 3 km downstream of the confluence with South Fork Big Deer Creek. As water quality improved, Rainbow Trout recolonized this site about 3 years later than at site BD-km5.3.

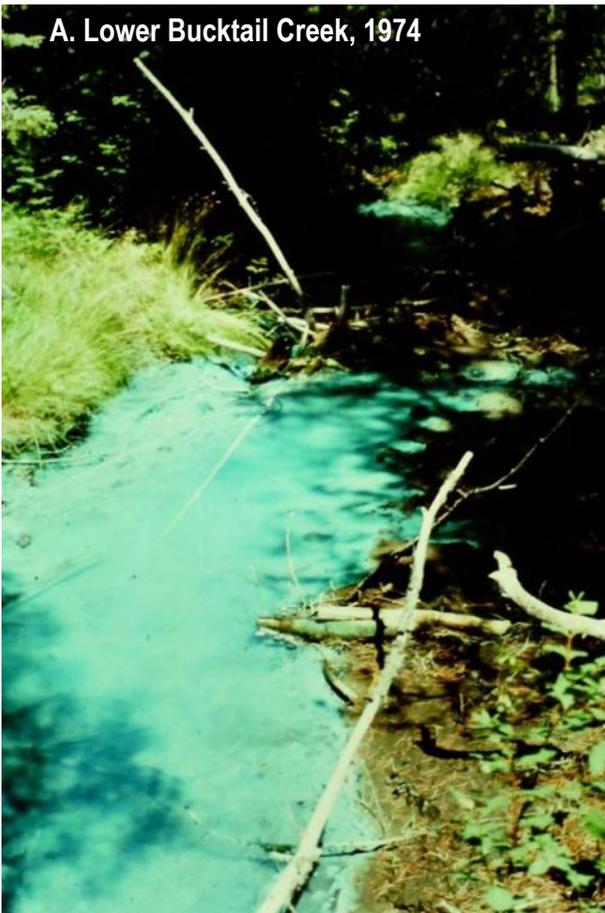
A. Lower Bucktail Creek, 1974

Figure S3-8 Changes in substrate appearance in Bucktail Creek, tributary to South Fork Big Deer Creek.

(A). Prior to water quality restoration efforts, metals concentrations draining from the Blackbird Mine to Bucktail Creek were extreme. Lower Bucktail Creek was covered in a dense, blue copper and cobalt rich precipitate.

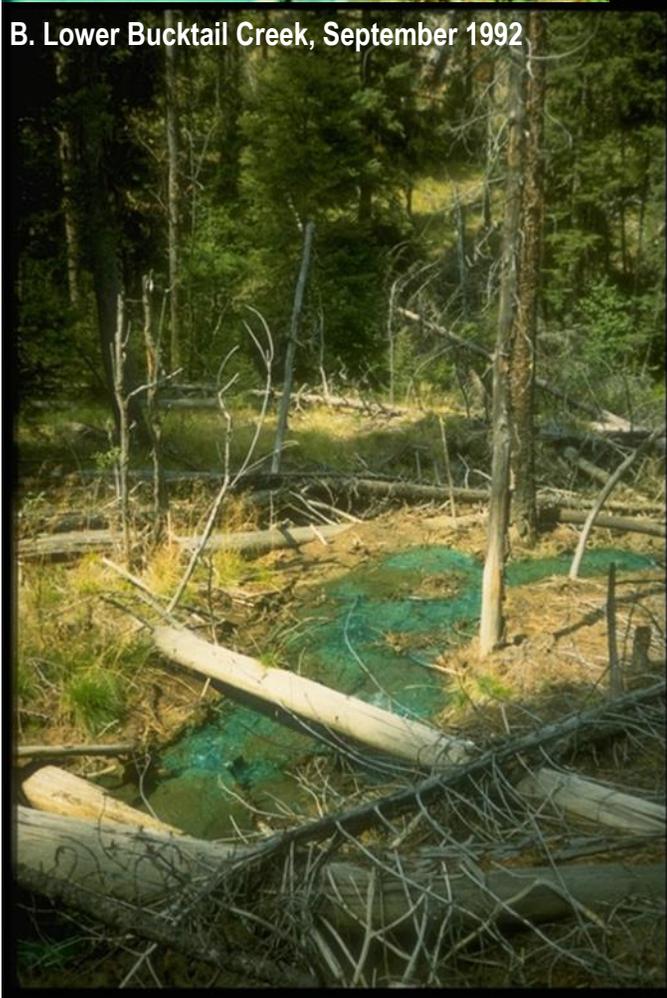
B. Lower Bucktail Creek, September 1992

(B) Lower Bucktail Creek, September 1992. Dissolved Co and Cu at this location were measured at 3495 and 4630 $\mu\text{g/L}$ respectively.

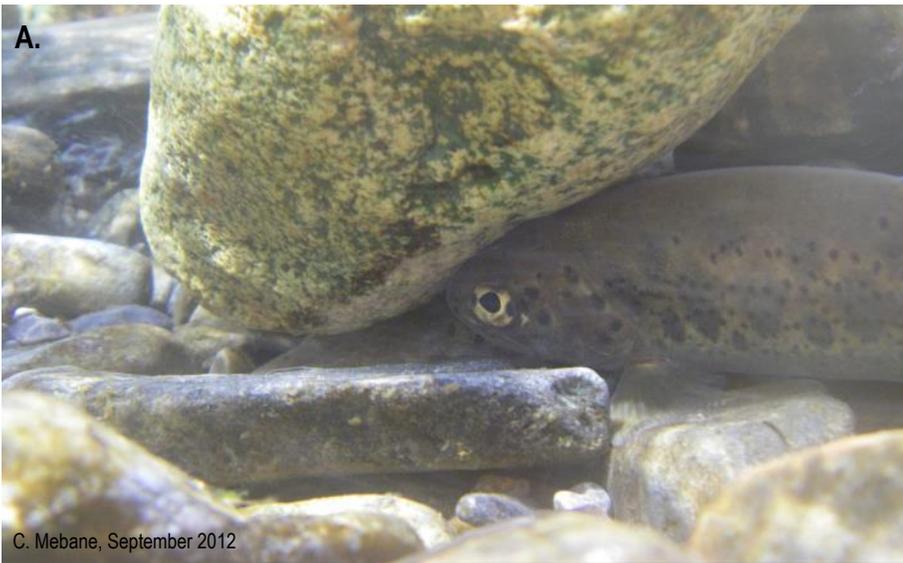
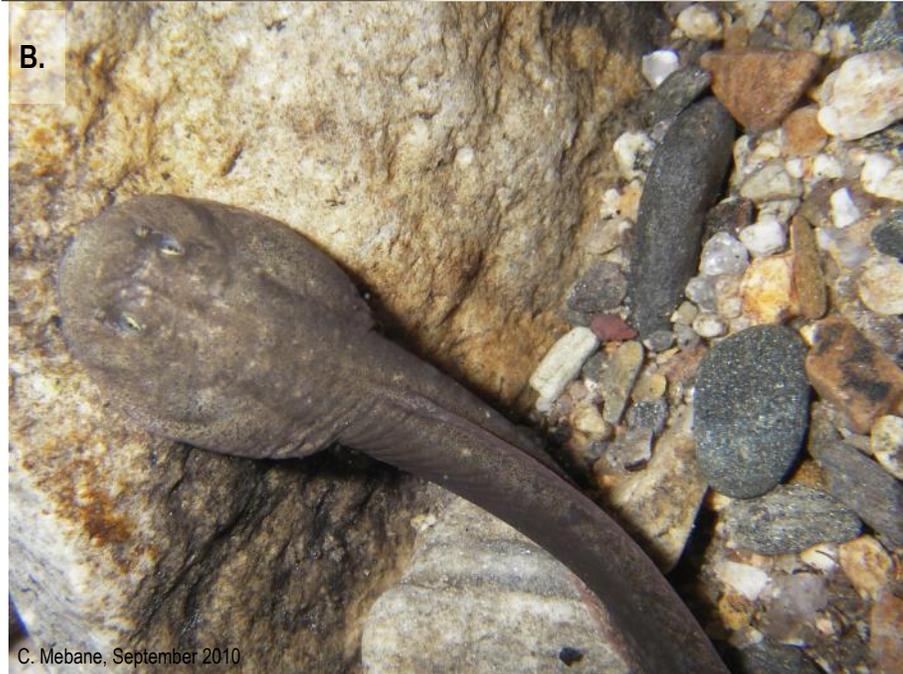
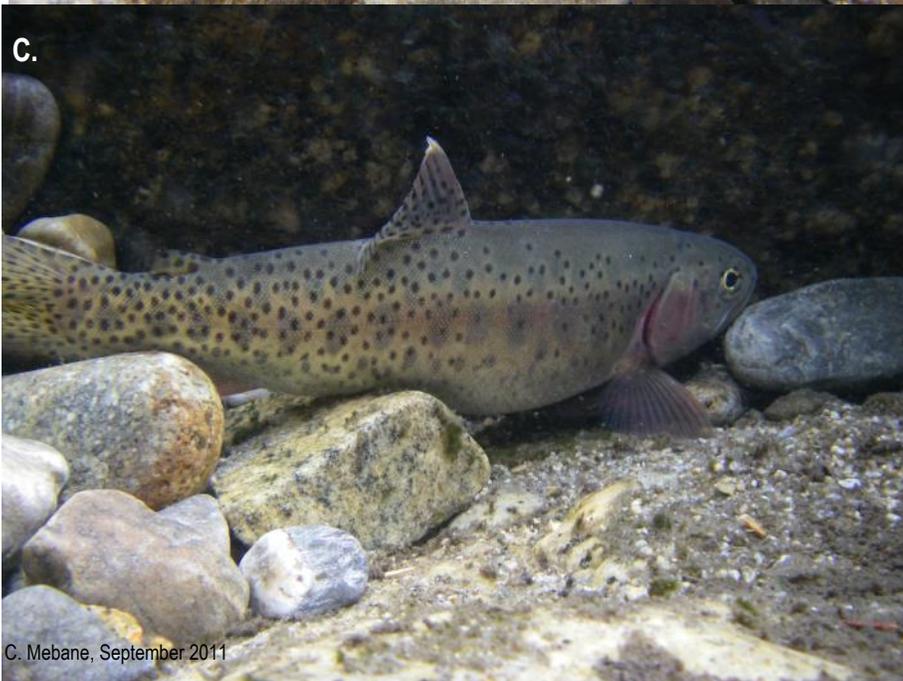
Figure S3-9. Substrates in Big Deer Creek characteristically have very low periphyton growth, and very clear water with very little suspended material.

(A). Even the most severely contaminated site, South Fork Big Deer Creek downstream of Bucktail Creek (SFBD-km0.1) has bare substrates without visual evidence of precipitates

Other examples are from mining-influenced (B) sites BD-km2.4, with a Rocky Mountain Tailed Frog tadpole (*Ascaphus montanus*), and (C) from site BD-km1.4, with a Cutthroat Trout (*O. clarki lewisi*)

Substrates at all mining-influenced sites on Big Deer Creek are visually indistinguishable from those at reference sites, with no precipitates visible by eye.

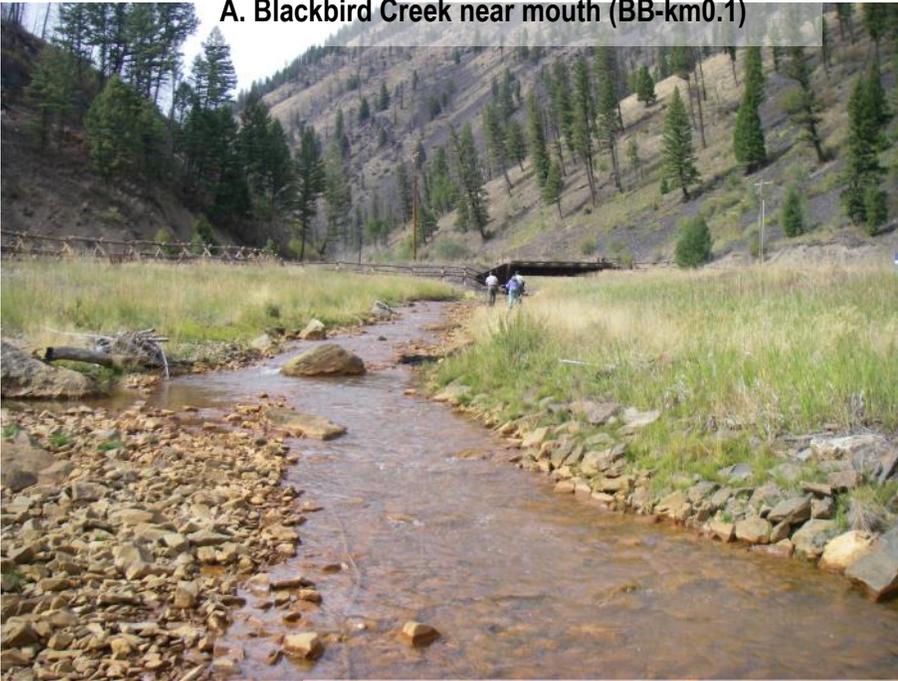
A. Blackbird Creek near mouth (BB-km0.1)

(A) Blackbird Creek near the mouth (BB-km0.1),

(C) Deep Creek near the mouth (reference for lower Blackbird Creek). Substrates and rocks along the waterline in lower Blackbird Creek have an obvious reddish hue, which extends to Panther Creek. Fish are reasonably abundant at this site, despite the substrate conditions and lack of riparian vegetation.

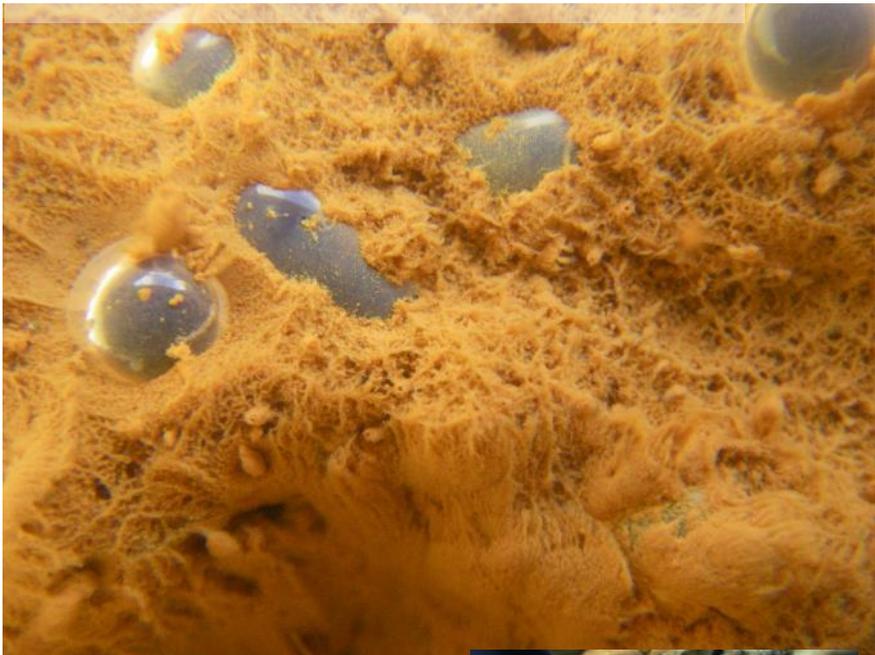
C. Substrate coatings in Blackbird Creek where fish were not present

2013). The iron-rich flocs at fishless sites were thicker, denser, and appeared to fill or block access to the interstitial spaces between rocks (C). No chironomids or any macroinvertebrates were obvious on the flocs, although

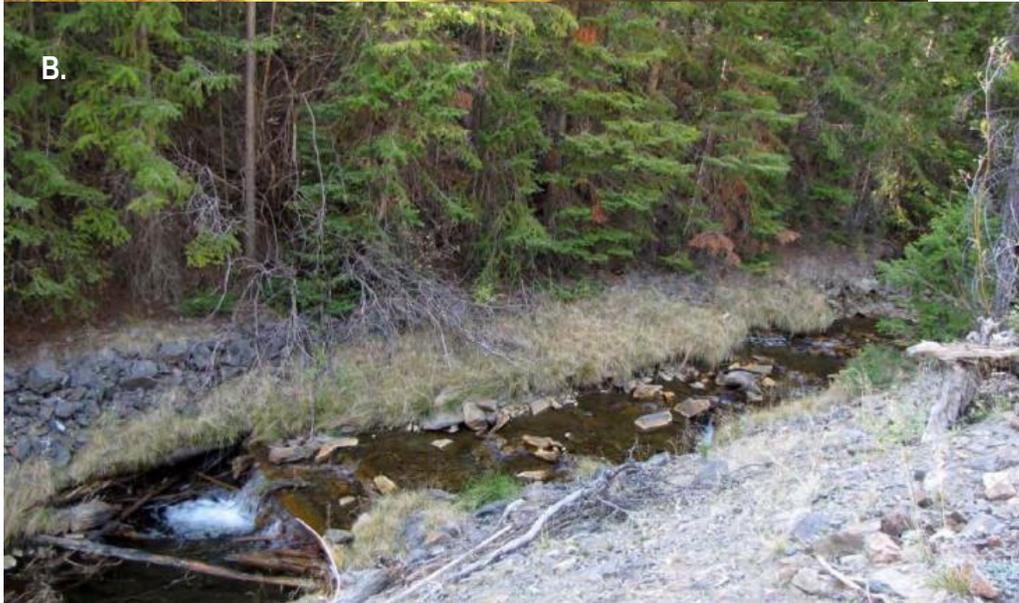
B.

(B). In Blackbird Creek upstream of the West Fork Blackbird Creek confluence, substrates are free from iron flocs, but no fish have been found. The location shown (BB-km9.2) is only 0.5 km below a source population of Cutthroat Trout occupying

undisturbed, upper Blackbird Creek. Dissolved Cu concentrations ranged from at least 24-40 $\mu\text{g/L}$ in this fishless reach, compared to 5-14 $\mu\text{g/L}$ in lower, fish bearing reaches.

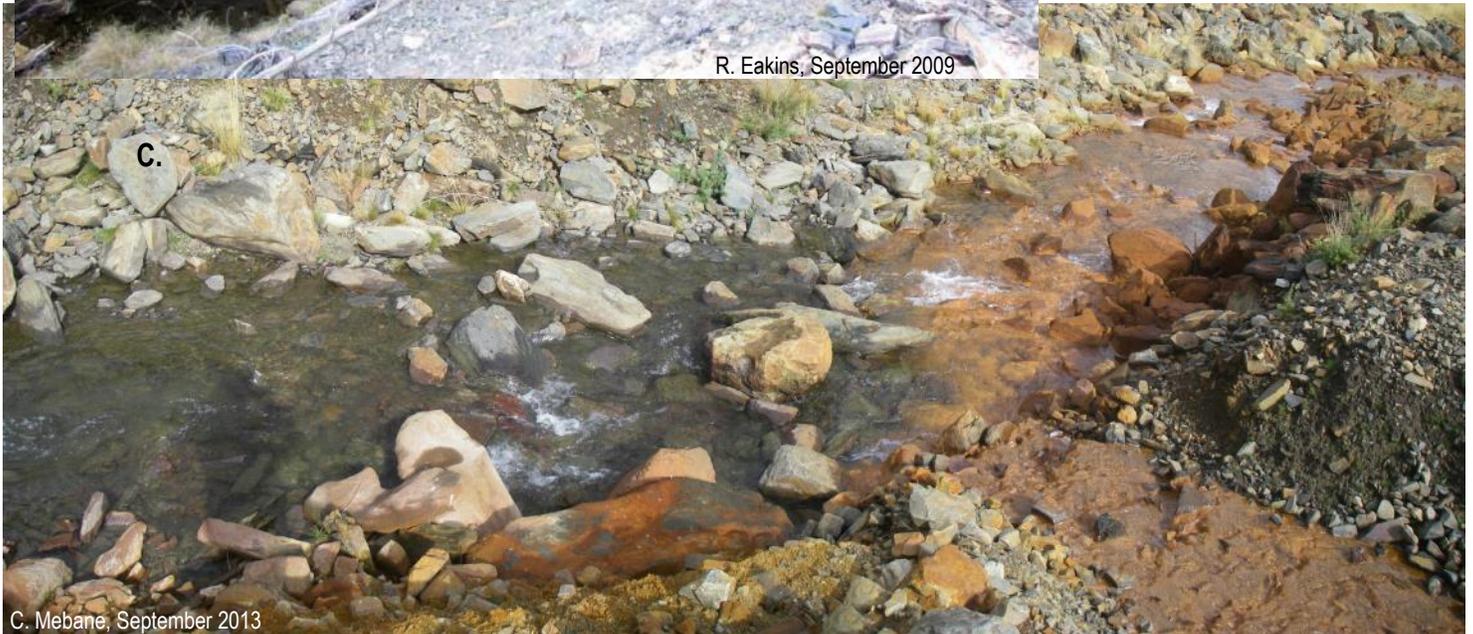
C.

(C). Mixing zone of iron and cobalt rich drainage from the toe of the West Fork tailings impoundment with Blackbird Creek, coming in from the left.

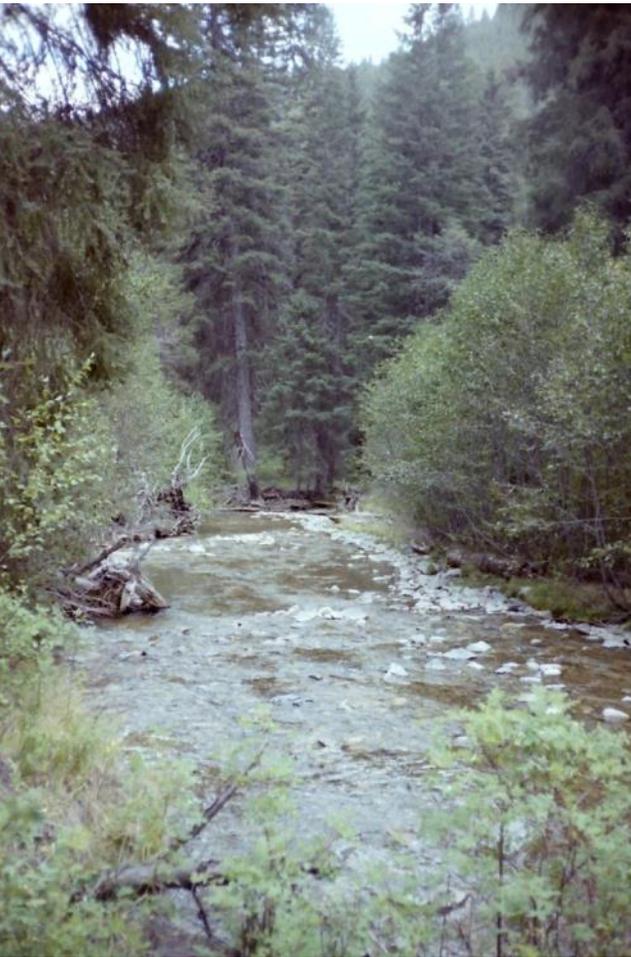
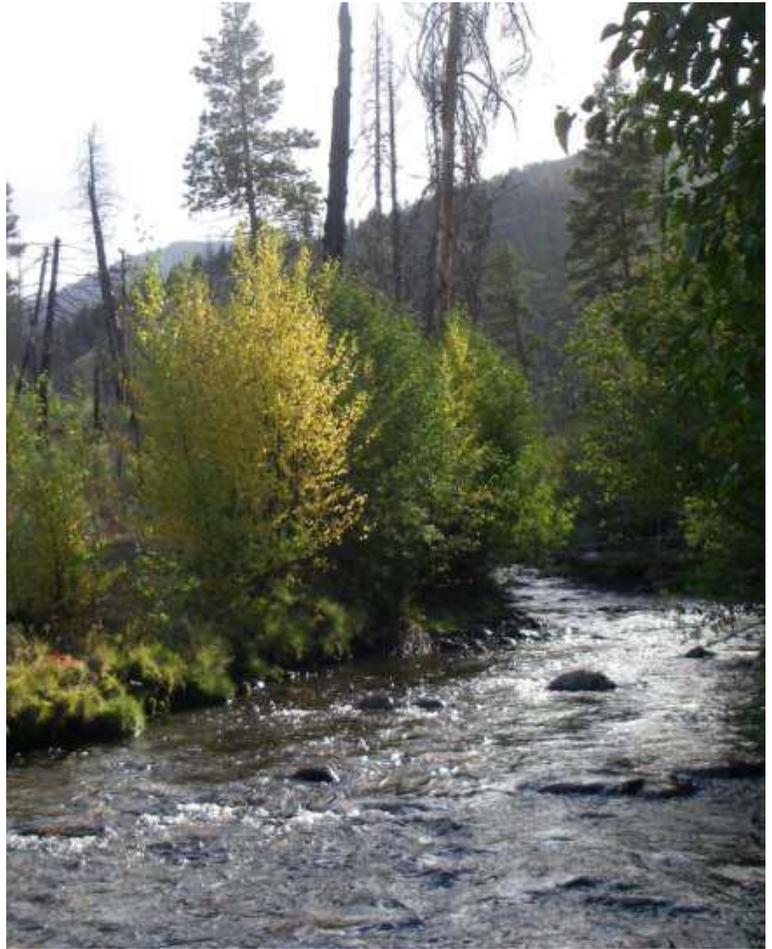
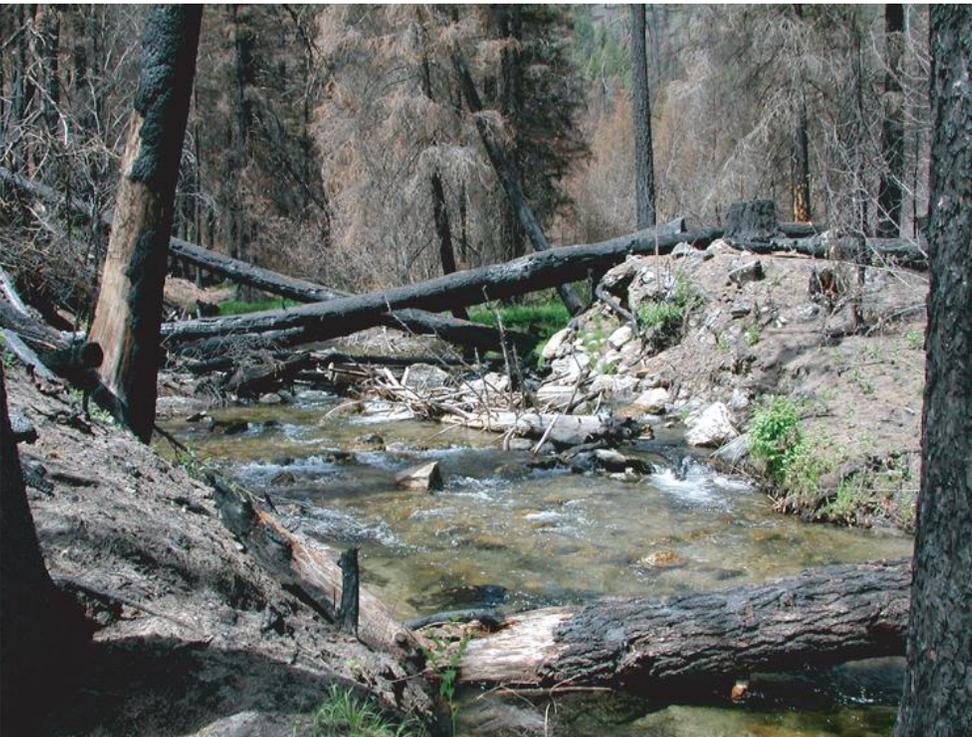
Figure S3-14. Views of Big Deer Creek near the confluence of South Fork Big Deer Creek, (A) prior to, (B) shortly after, and (C) 11 years after the Clear Creek forest fire of August-October 2000. Prior to burning, Big Deer Creek riparian zone had canopy of conifers up to about 40m in height (A), which were mostly killed by the fire (B). Subsequently, the riparian zone has regrown with alders of <10m in height (C). The expected influences of the fire include increased sedimentation from loss of vegetation and in-

creased solar insolation, increased productivity, and increased summer stream temperatures.
